FINAL FISHERIES SPECIALIST REPORT (ROUND 2, FINAL)

CAMERON PEAK FIRE: BURNED AREA EMERGENCY RESPONSE (BAER) ASSESSMENT

ARAPAHO & ROOSEVELT NATIONAL FORESTS

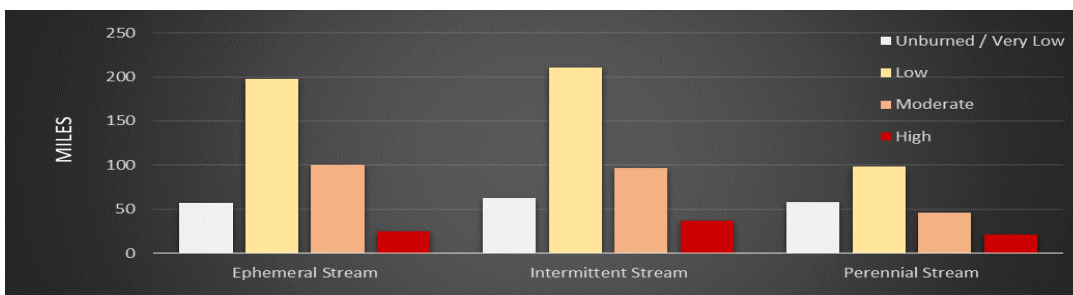
The Cameron Peak Fire burned around and over significant amounts of aquatic habitat, including streams, lakes, and wetlands. Approximately 165 miles of perennial stream experienced fire nearby and the length of intermittent stream habitat feeding into perennial streams exceeded 340 miles (Figure 1).

FIGURE 1. SUMMARY OF BURN SEVERITY FROM THE CAMERON PEAK FIRE ACROSS STREAM TYPE WITHIN THE CACHE LA POUDDRE, LARAMIE, AND BIG THOMPSON RIVERS.

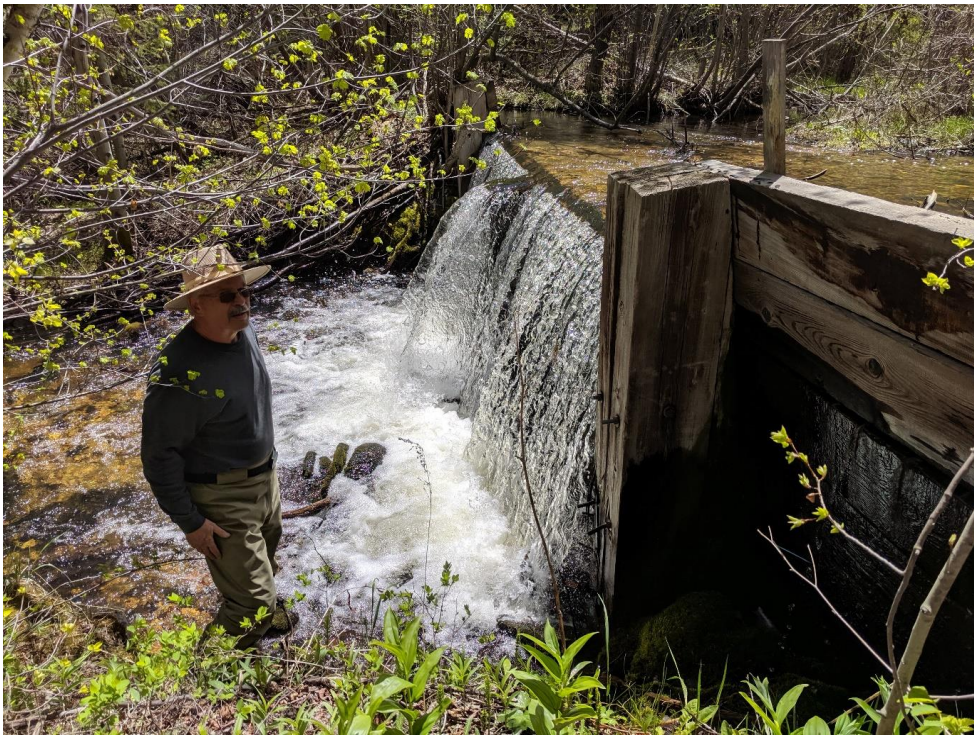
Cutthroat trout present in Black Hollow are representative of cutthroat trout native to the Yampa River basin in western Colorado and are now managed as Region 2 Sensitive Species (see Table 1). Cutthroat have persisted in this stream due to a timber-frame wooden barrier constructed in the early 1980s (Figure 2). In 2019, Forest Service staff found the structural condition of the barrier sound, despite the intense flood flows this area experienced in September 2013. The barrier has protected the small, isolated habitat patch from invasion from non-native fish (USDA Forest Service 2019A). Assessments and surveys (Young and Guenther-Gloss 2004, Colorado Parks and Wildlife unpublished data, Forest Service unpublished data) since the 1980s have documented a low population size (< 500 adult fish) related to limited habitat patch size, limited pool habitat, and cold water temperatures that could limit long-term viability of the population.

FIGURE 2. PHOTOGRAPH OF BLACK HOLLOW FISH BARRIER DEPICTING CONDITION OF TIMBERS AND LOCAL BANK STABILITY FROM 2019 (FROM USDA FOREST SERVICE 2019).

- **Black Hollow** – Stream assessments were conducted from the Crown Point Road (FSR 169) and the stream mouth upstream from the confluence with the Cache la Poudre River. Fire spread burned laterally across the upper watershed segments and indicated extensive areas of moderate to high severity burn. Views into the burn area indicated widespread loss of forest, forest canopy, and living vegetation. Streambanks were still intact with most organic material adjacent to the channel being charred on the surface, but not within the soil. Lower portions of this watershed where the primary cutthroat trout habitat occurs burned with high severity. The wooden barrier structure was partially consumed by the fire and likely accelerated the structure’s trajectory toward failure. Although still standing and functional, water seepage was occurring in the soils along the flanks of the wooden wingwalls embedded in the streambanks and the primary support timbers were severely charred (Figure 2). The local topography surrounding the structure indicates that even small increases in bedload transport are likely to deposit upstream of the structure causing the stream channel to avulse and bypass the structure.

- Black Hollow Fish Barrier. The condition and status of the existing wooden barrier should be monitored and evaluated for debris flow following post-fire precipitation. The isolated habitat should be evaluated to determine if the area should continue to be managed as suitable habitat for greenback cutthroat trout. Several habitat factors should be considered in light of the anticipated habitat changes resulting from the fire and post-fire effects, such as stream temperature regime, channel stability, presence of quality spawning habitat, quality and quantity of pool habitat, and overhead cover. In addition, an effective barrier to prevent non-native fish invasion would be needed. If habitat conditions are suitable, I recommend rebuilding the fish barrier lower in the drainage and closer to the stream mouth than the existing barrier. There are site options near the forest boundary and at road-stream crossings on private land near the stream mouth.

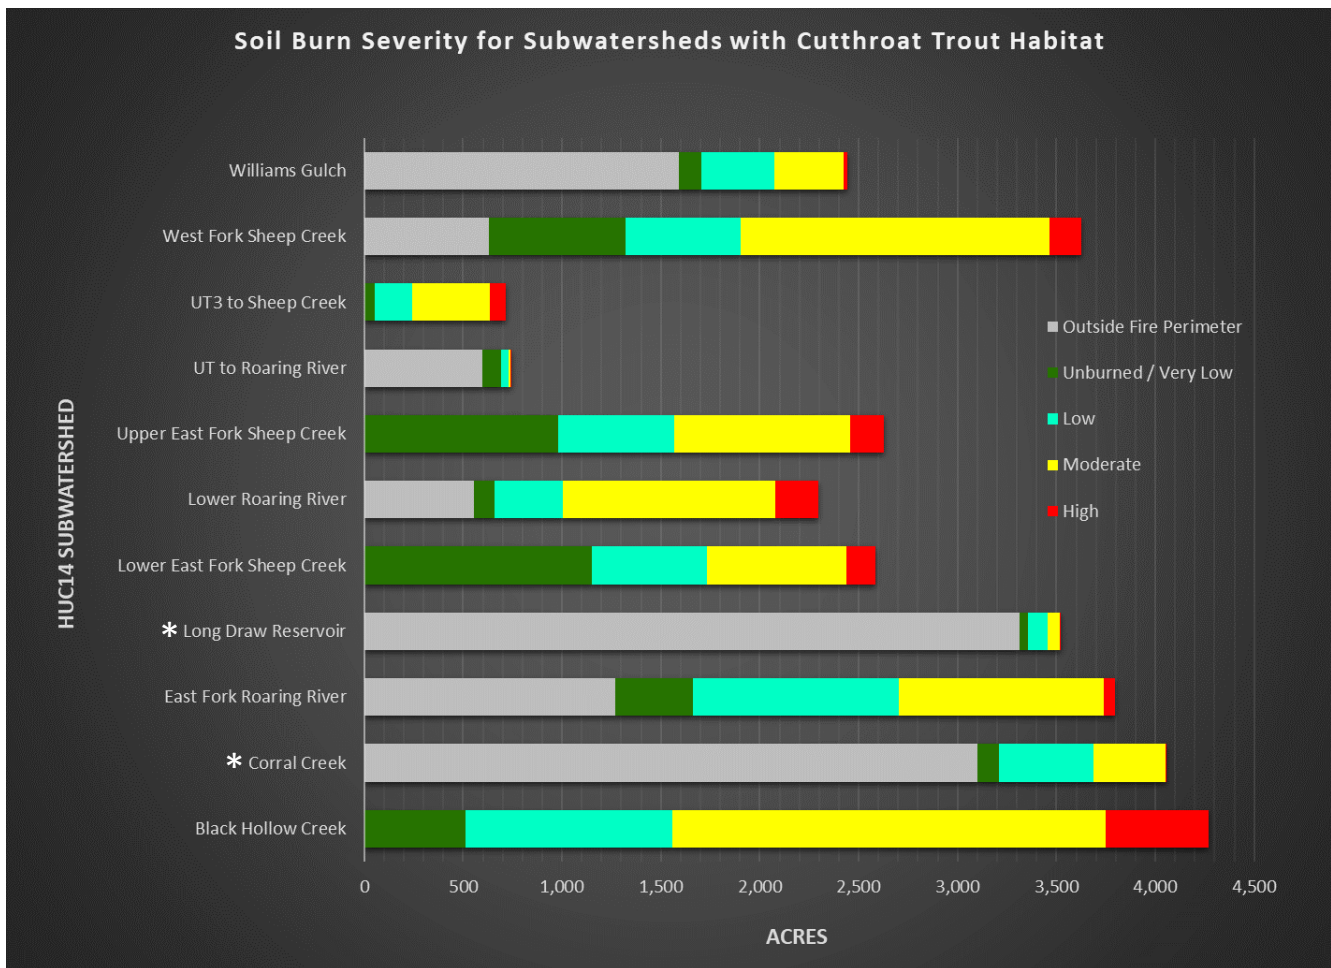
The Cameron Peak Fire produced a mix of soil burn severity across 208,760 acres within the Cache la Poudre River, Laramie River, and Big Thompson River watersheds (Hydrology BAER Report). Watershed analyses of soil burn severity at the time of assessment presented a similar mixture of soil burn severity for the watersheds containing cutthroat trout habitat, natural fish barriers, and a FS-owned & constructed fish barrier (Table 4, Figure 3). The HUC 12 watersheds were larger than the scale at which cutthroat trout and their habitat occur on the landscape. Soil burn severity examined at a finer watershed scale for the available delineated HUC14 watersheds highlights a range of burn severity across the cutthroat trout habitats, with greatest potential for post-fire effects in the Sheep Creeks and Black Hollow (Figure 3).

FIGURE 3. CUMULATIVE SOIL BURN SEVERITY ACROSS HIGH, MODERATE, LOW, AND UNBURNED CLASSES FOR HUC14 WATERSHEDS CONTAINING CUTTHROAT TROUT HABITAT VALUES. WATERSHEDS WITH AN ASTERISK (*) REPRESENT SUITABLE OR PROSPECTIVE HABITATS.

Post-fire impacts to aquatic ecosystems have been well-studied. Based on the burning conditions of the Cameron Peak Fire and the current state of resource conditions, there are a number of post-fire responses that can be reasonably expected to occur within 3-5 years after following the fire (see Figure 3). In the short-term of the

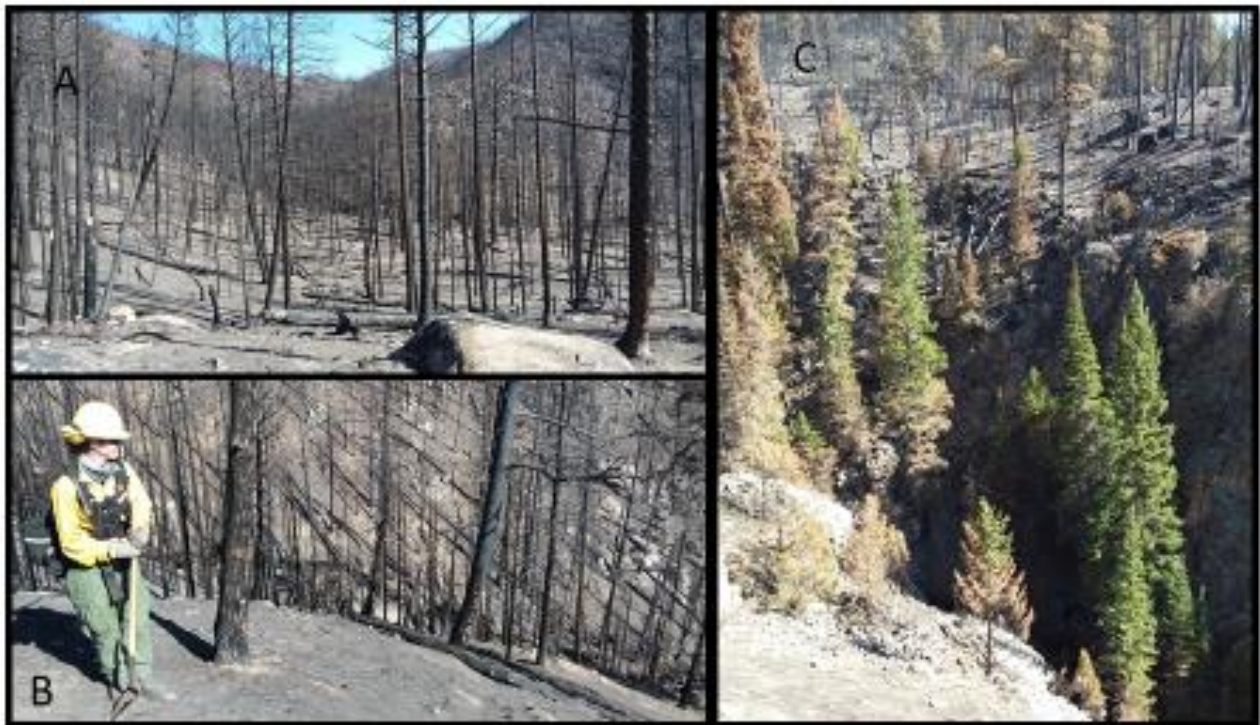
- **East Fork Roaring Creek** – Fire activity and aerial fire suppression activities persisted throughout the Round 1 BAER field assessment period. The stream assessed on October 22, 2020. The fire continued to burn into the upper reaches of the watershed including all reaches with habitat suitable for supporting fish. Based on intensity of suppression efforts, smoke plumes observed, and on-the-ground field assessment (Figure 6), this watershed burned with moderate to high intensity. Forest cover type along the valley bottom and channel margins are this stream differ little from adjacent upland vegetation. Habitat conditions were likely affected by the fire and are likely to experience post-fire effects with little to no remaining riparian vegetation capable of attenuating sedimentation from hillslope erosion. Further assessment was based on geospatial and modelled post-fire outcomes.

FIGURE 6. PHOTOGRAPHS OF POST-BURN CONDITIONS IN EAST FORK ROARING CREEK: (A) UPVALLEY VIEW OF LOWER WATERSHED, (B) CROSS-VALLEY VIEW OF LOWER WATERSHED, AND (C) VIEW OF BEDROCK CONTROLLED BARRIER REACH.

- Occupied greenback cutthroat trout habitat in East Fork Roaring Creek. Habitat conditions in this stream should be monitored in the spring and summer of 2021 when safe access can be granted to determine the fate of recently introduced greenback cutthroat trout and suitability of the habitat to support aquatic life and greenback cutthroat trout. Routine population, occurrence, and habitat monitoring should be scheduled over the next 1-3 years to evaluate reintroduction efforts.*

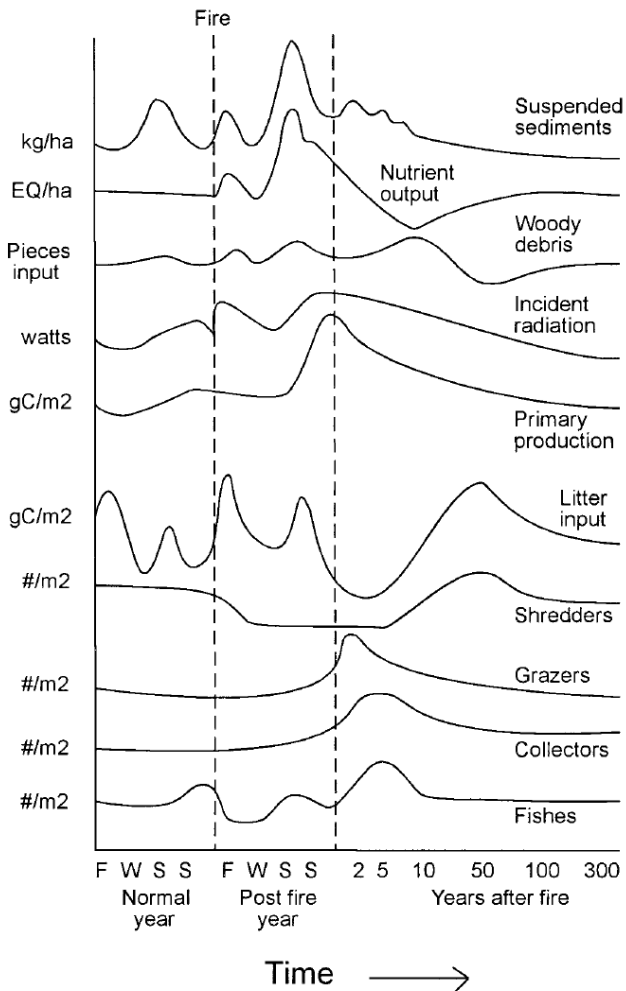
FIGURE 7. TIME-SERIES DIAGRAM OF POST-FIRE RESPONSES TO COMPONENTS OF AQUATIC ECOSYSTEMS. ADAPTED FROM MINSHALL AND OTHERS (1989).
